AFRL-ML-WP-TR-1998-4212

**B-1 AIRCRAFT MAIN HYDRAULIC
PUMP TESTS WITH MIL-H-87257
HYDRAULIC FLUID**

JUNE 1998

FINAL REPORT FOR PERIOD JUNE 1 1992 – SEPTEMBER 30, 1993

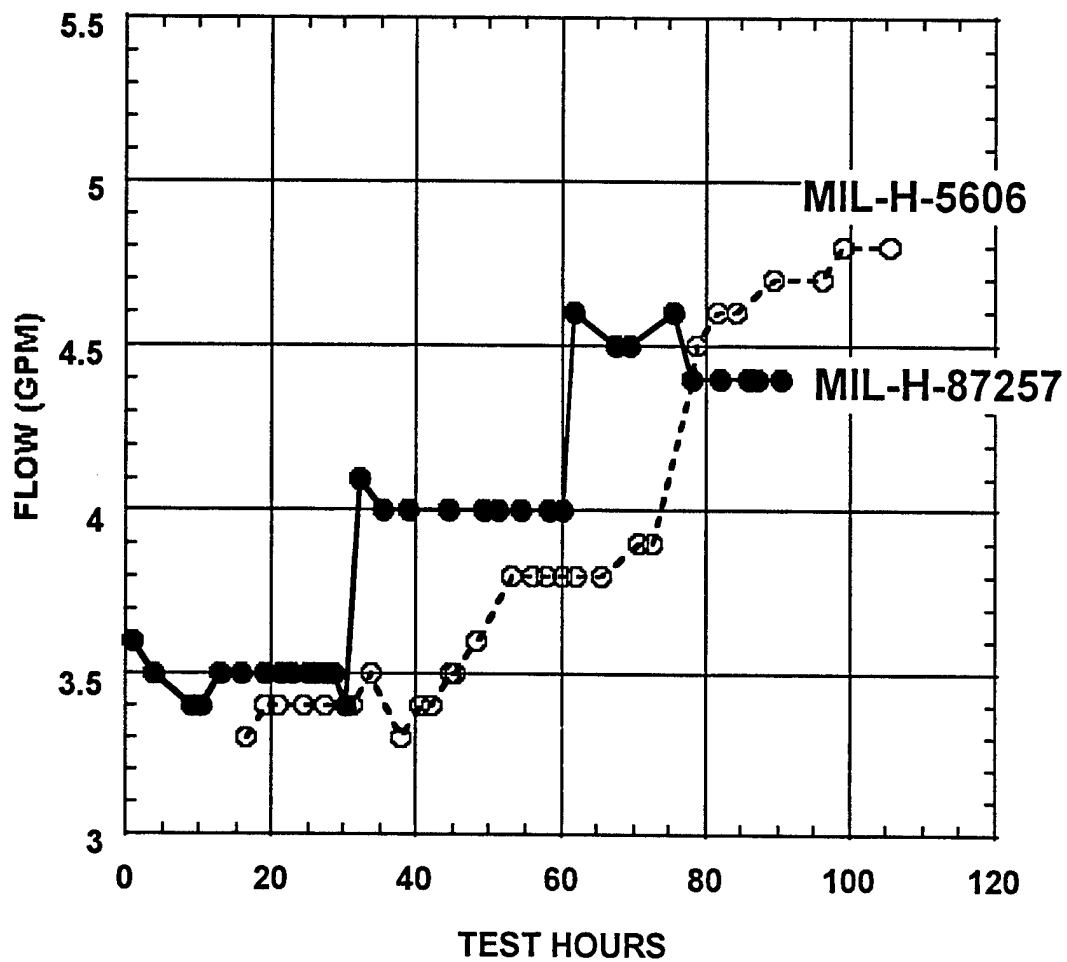
Figure 3. Case drain flow in B-1 pump tests

The pump case drain flow rates were observed and recorded during both pump tests. A comparison plot of the data is shown in Figure 3. It is interesting to note the case drain flow rates for the MIL-H-5606F fluid start out lower, but end up at a higher rate when compared to the flow rates for MIL-H-87257 fluid. This is attributed to the loss of viscosity of MIL-H-5606 with time due to its shear instability, discussed later.

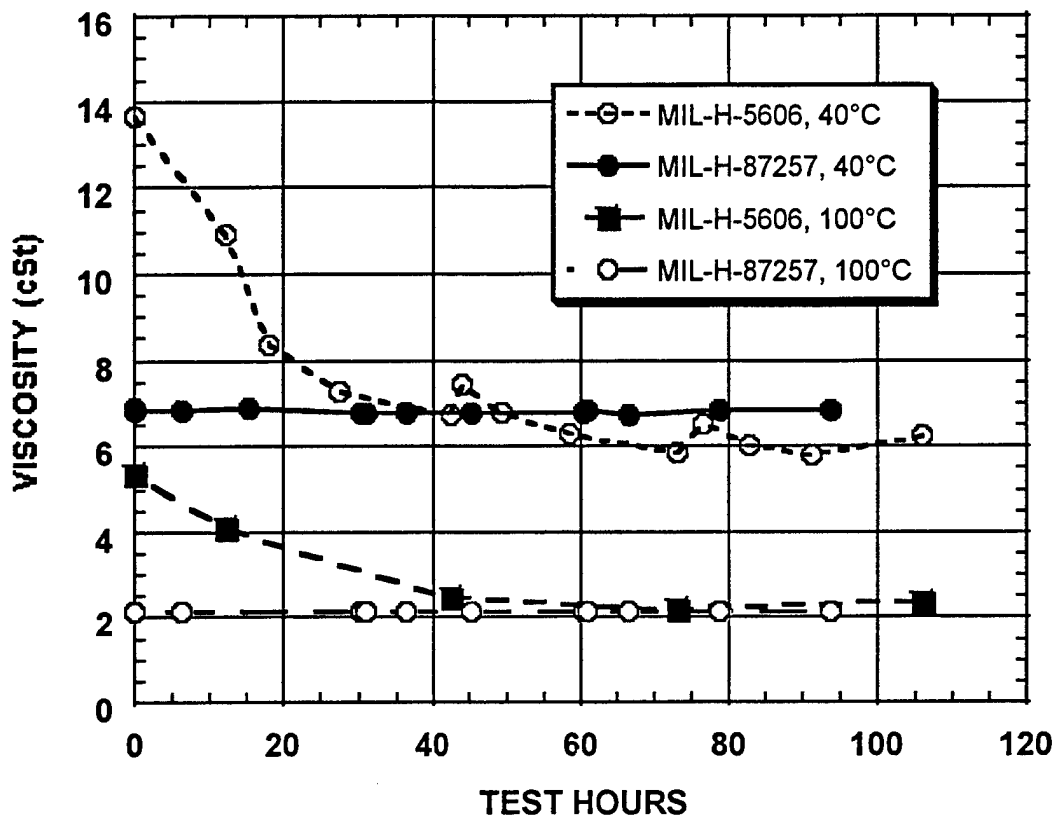
Figure 4. Viscosity change in B-1 pump tests

The viscosities of the fluid samples taken were determined at 40 °C and 100 °C. These viscosities are compared in Figure 4. It is easily seen that MIL-H-5606F suffered significant viscosity losses during the first 30 hours of pump testing, whereas the viscosity of MIL-H-87257 was very stable throughout the test. The viscosity index (VI) improvers used to boost the viscosity of MIL-H-5606, break-up under the high shear environment inside the pump, causing a permanent loss of the fluid viscosity. Under the high pressure and high shear rate environment, the VI improved fluids behave more like the base oil (Reference 1).

4.3 Viscosity of MIL-H-5606 reduced by 50% during the first 30 hours of testing.

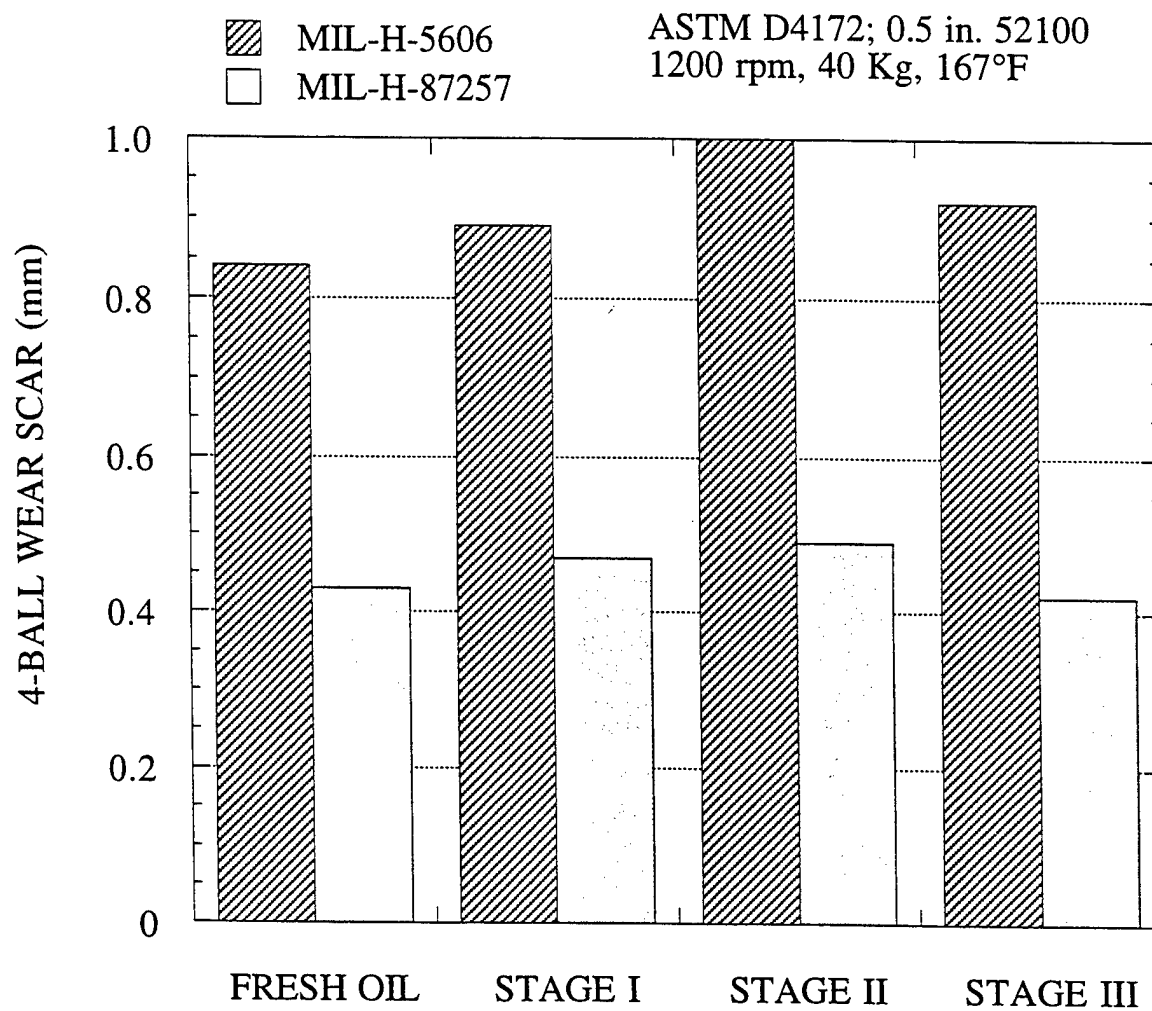
Figure 5. Four-Ball Wear Scar with B-1
Pump Test Fluid Samples

Samples taken at the end of each stage of testing and the fresh samples of each of the test fluids were evaluated for lubricity. These evaluations were accomplished by 4-ball wear testing method (ASTM D-

4172). The results of the lubricity tests are shown in Figure 5. Clearly, these data indicate better lubricity for MIL-H-87257 when compared to MIL-H-5606F.

4.2 MIL-H-87257 exhibited better lubricity than MIL-H-5606, as determined by the ASTM D-4172 four-ball wear tests.
